GUIDE TO REDUCE ROAD FAILURES IN WESTERN OREGON

Edward R. Burroughs, Jr.
George R. Chalfant
Martin A. Townsend

August 1973

Bureau of Land Management
Oregon State Office
P.O. Box 2965
Portland, Oregon 97208

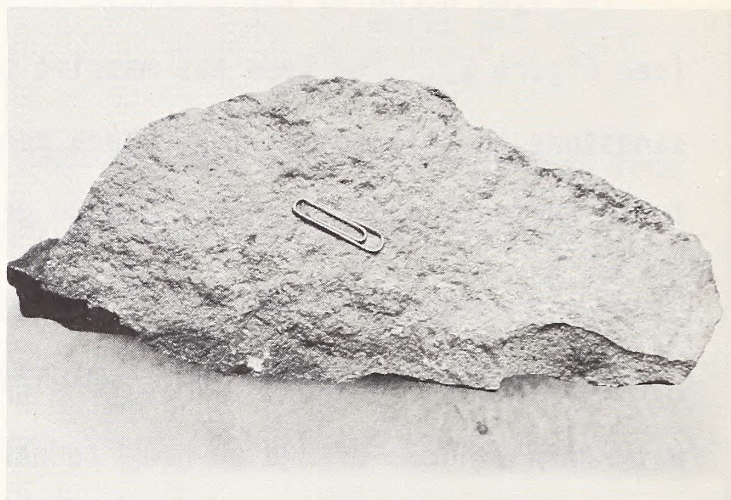
Figure 3b. Yamhill formation.

The Yamhill formation contains massive gray to greenish-gray sandstone with thinner beds of medium-gray to dark-gray, mudstone, shale, or siltstone (see Figures 3b and 5). The Yamhill is found in two general areas (Figure 2); one west of Salem and another northeast of Coos Bay.

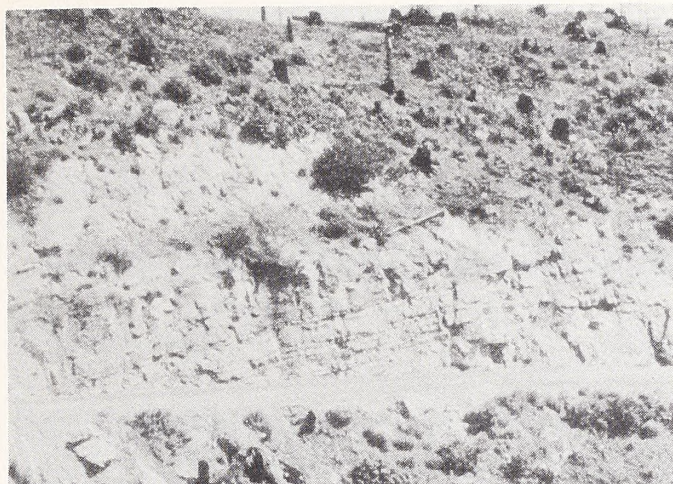
Figure 4. Tyee formation

The Tyee occupies the greatest area of any formation in western Oregon (see Figure 2). The Tyee has massive beds, each of which grades upward from sandstone to siltstone. The colors range from medium-gray to bluish-gray on fresh surfaces and may appear tan to gray on weathered surfaces (see Figures 3a and 4).

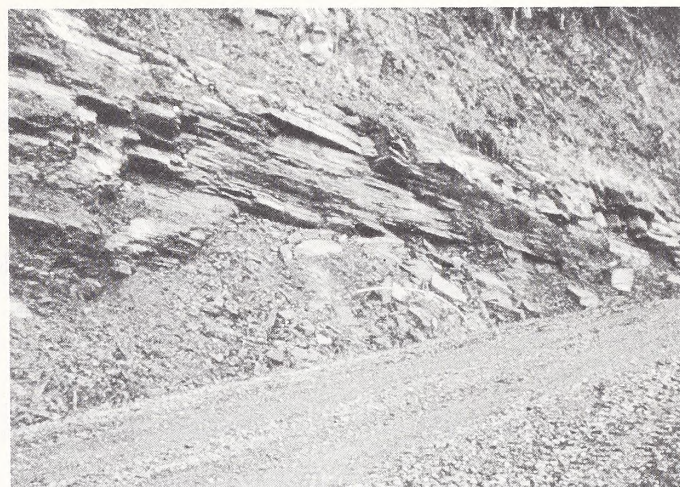
Figure 5. Yamhill formation

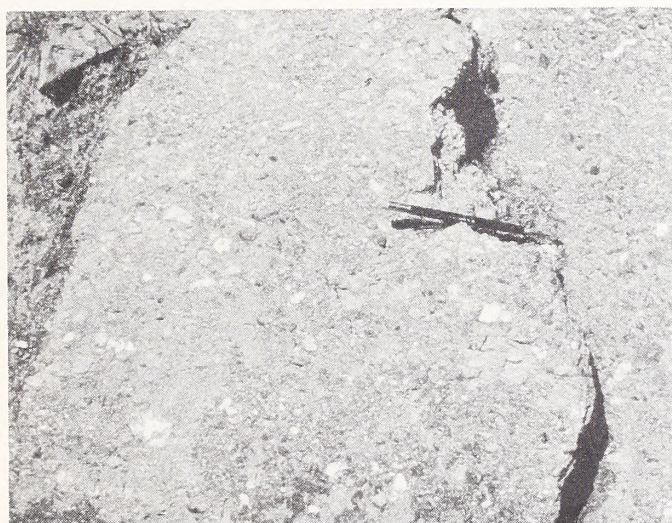
Figure 6. Conglomerate portion of the Umpqua formation

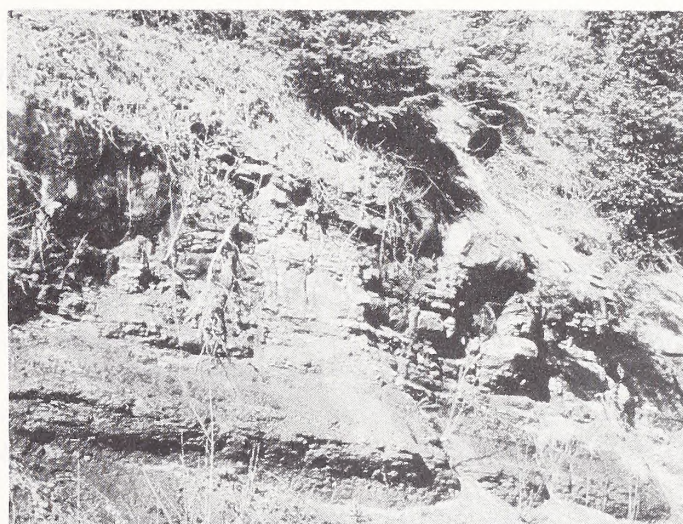
Figure 7. Sandstone portion of the Umpqua formation

The Umpqua is a complex formation with three major units or subdivisions. The lowest (or oldest) unit contains some volcanic rock in addition to beds of sedimentary rock. This material may be seen along Highway 42 between Coquille and Myrtle Point and also around Roseburg. The middle unit grades upward from thick layers of conglomerate through sandstone to siltstone; this material may be seen between Tenmile Creek and Lookingglass Creek southwest of Roseburg. The upper (youngest) unit is composed of pebbly conglomerate (Figures 3c and 6) that grades upward into siltstone and is found from Camas Valley almost to Dutchman Butte, southwest of Roseburg. Some portions of the Umpqua formation may be darker than either the Tyee or Yamhill formations (Figures 3d and 7); the layers of siltstone, in particular, tend to be very dark.

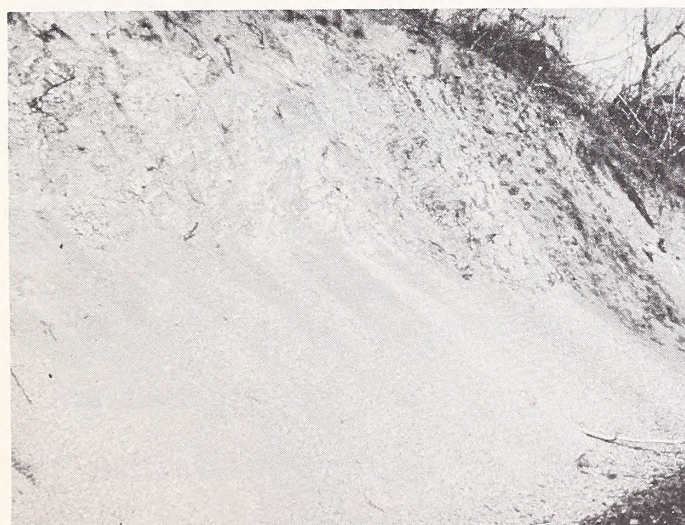
Figure 8. Nestucca formation showing weathered siltstone

The Nestucca formation covers a large block northwest of Salem and is composed of interbedded siltstone (Figures 3e and 8), claystone and sandstone. In many places the Nestucca formation is intersected by flows of volcanic rock.

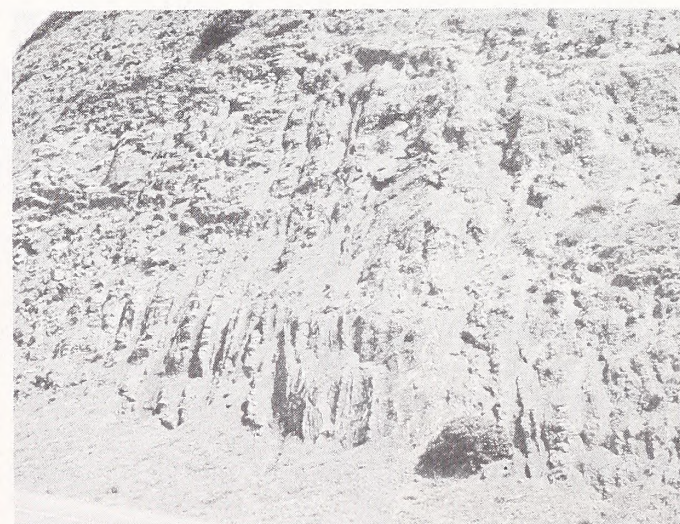
Figure 9. Otter Point formation

The appearance of the Otter Point formation, and associated formations with similar characteristics, is that of highly sheared, tan, dark-gray or black sandstone with interstratified thin mudstone, minor conglomerate, and volcanic material (Figures 3f and 9). This material occurs in small areas from Myrtle Creek (south of Roseburg) on west to a large block along the southwest Oregon coast.

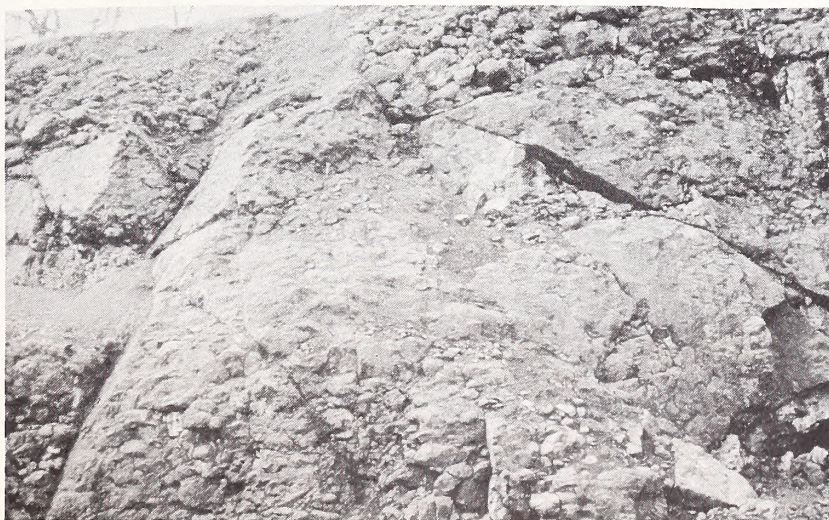
Figure 10. Pillow lava showing characteristic rounded shapes

marine basalt or pillow lavas because of their characteristic shape (Figure 10) and these tend to be relatively soft and easily eroded. This material is common in a large block of igneous rock in the Coast Range northeast of Tillamook (Figure 2).

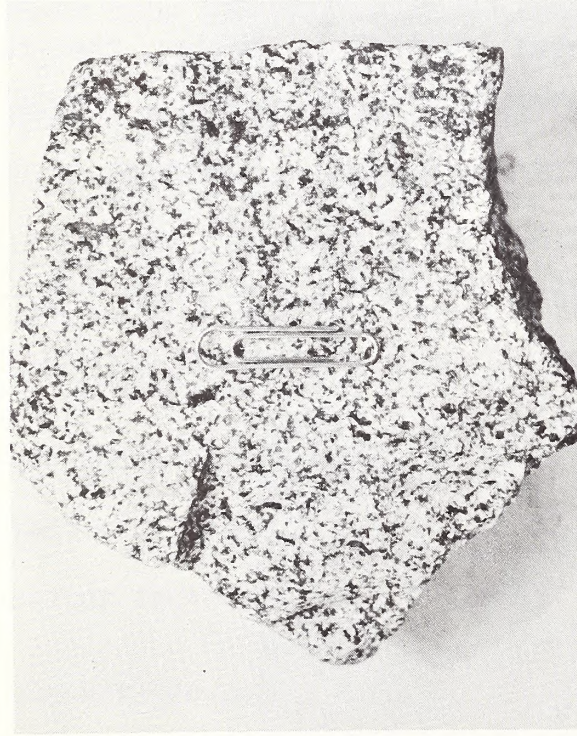
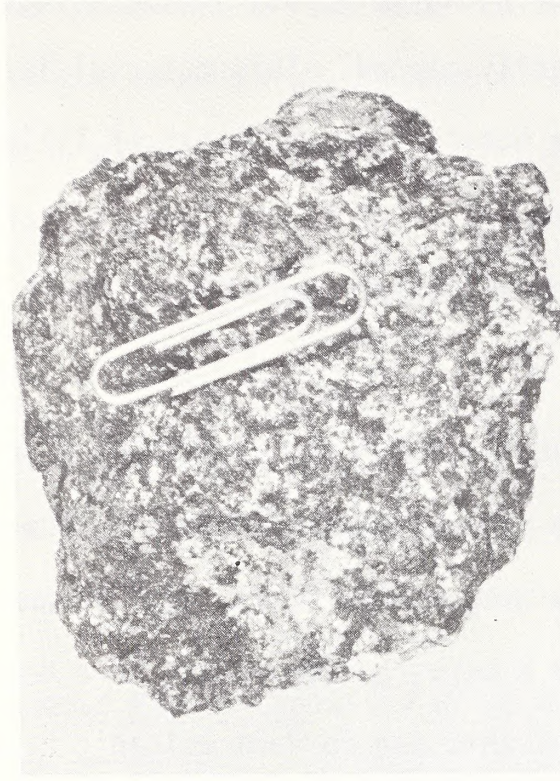
LIGHTER COLORED

COARSER
TEXTURED

DIORITE

DARKER COLORED

GABBRO

FINER
TEXTURED

ANDESITE

BASALT

Figure 11. Four common intrusive and extrusive igneous rocks

Photographs of four common extrusive and intrusive rocks are shown on Figure 11.

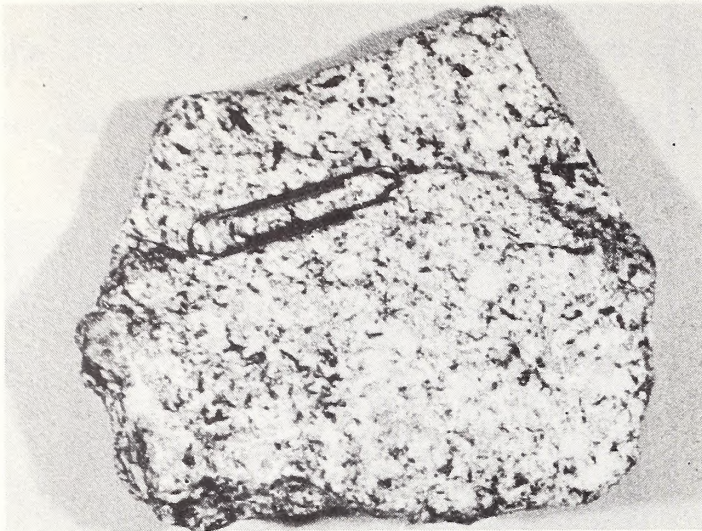
Figure 14. Granite is light colored and coarse-grained

Granite is a light-colored, coarse-grained rock (Figure 14) which is formed when molten material is intruded into surrounding rock; the rate of cooling is very slow and mineral crystals grow large. Variations in the chemical composition of this intrusive material creates a wide spectrum of granitoid (or granite-like) rocks (Figure 15). Weathered granitoid rock tends to crumble easily into a coarse "sand" as the weathering process degrades the grain-to-grain contact that holds the large crystals together. Granitoid rocks are found in the Klamath Mountains (also known as the Siskiyou Mountains) and in isolated spots in the Cascades (Figure 2).

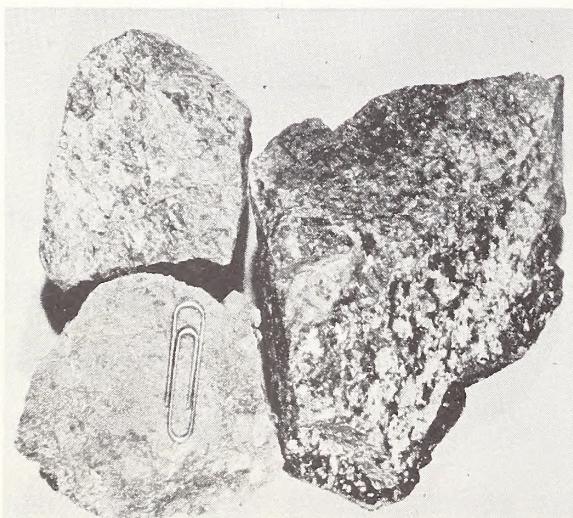
Figure 19. Serpentine may range from yellow-green, through bluish-white, to black

The color of serpentine ranges from yellow-green, bluish-green, or olive-green to almost black (Figures 19 and 20). Note in Figure 2 that serpentine appears as extensive areas and also quite frequently as thin belts or streaks, oriented southwest to northeast in the Klamath Mountains and along the southwest coast.

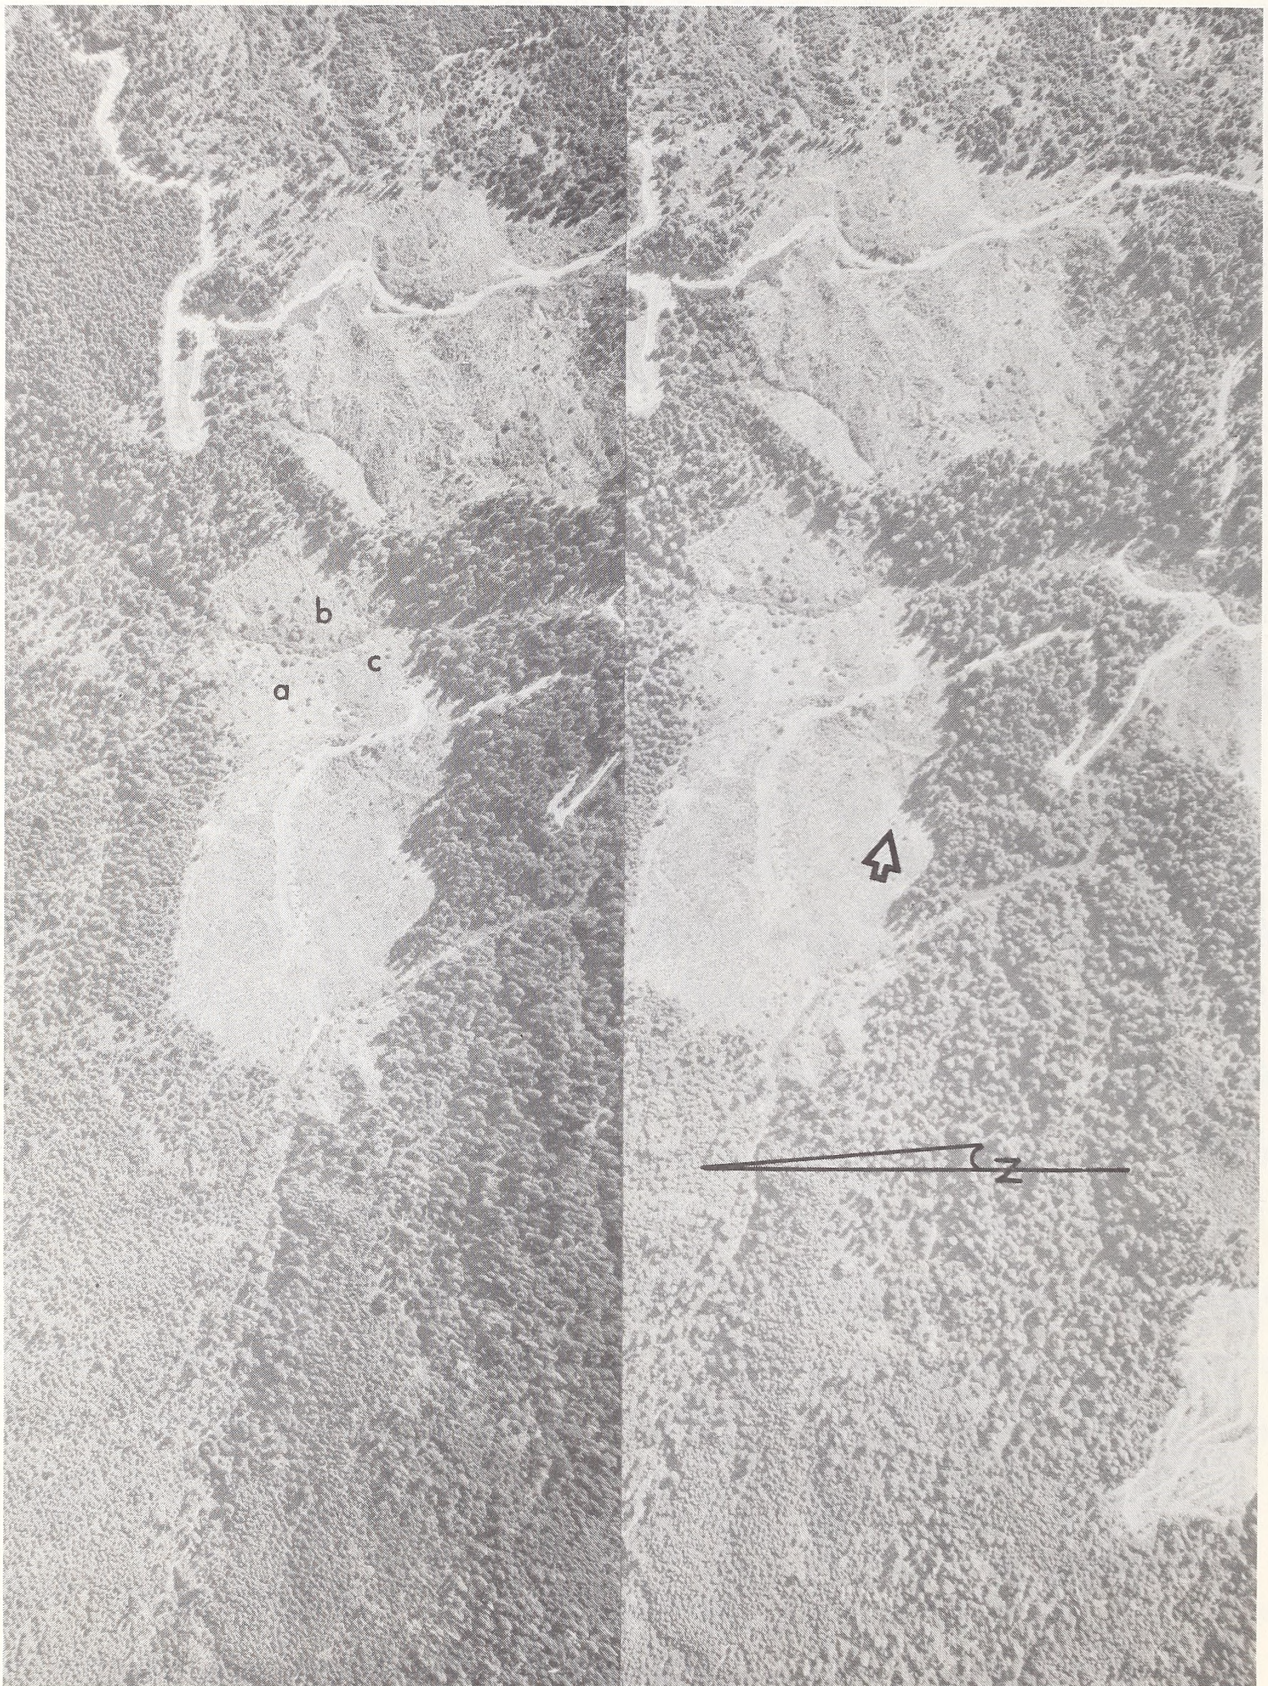
Figure 22. Stereogram of fault zone outlined in Section 27 of Figure 21. Large slump in center of photo; actively failing slopes at a and b. Arrow points to a dry sag pond below the slump.

A rectangular area is outlined on the topographic map in Section 21, and a stereogram that was developed from aerial photography of this area is shown in Figure 22. The locations of the fault zones were transferred from the topographic map to the stereogram. An examination of the stereogram through a stereoscope will show that there is a large slope failure on the fault zone. This is an old failure as indicated by the lack of exposed soil and by the fact that mature timber was harvested from this area. An examination of this area on the ground showed that igneous rock had intruded into the fault, that the slopes at A and B are actively moving, and that the slope at C has slid into the stream since these photographs were taken.

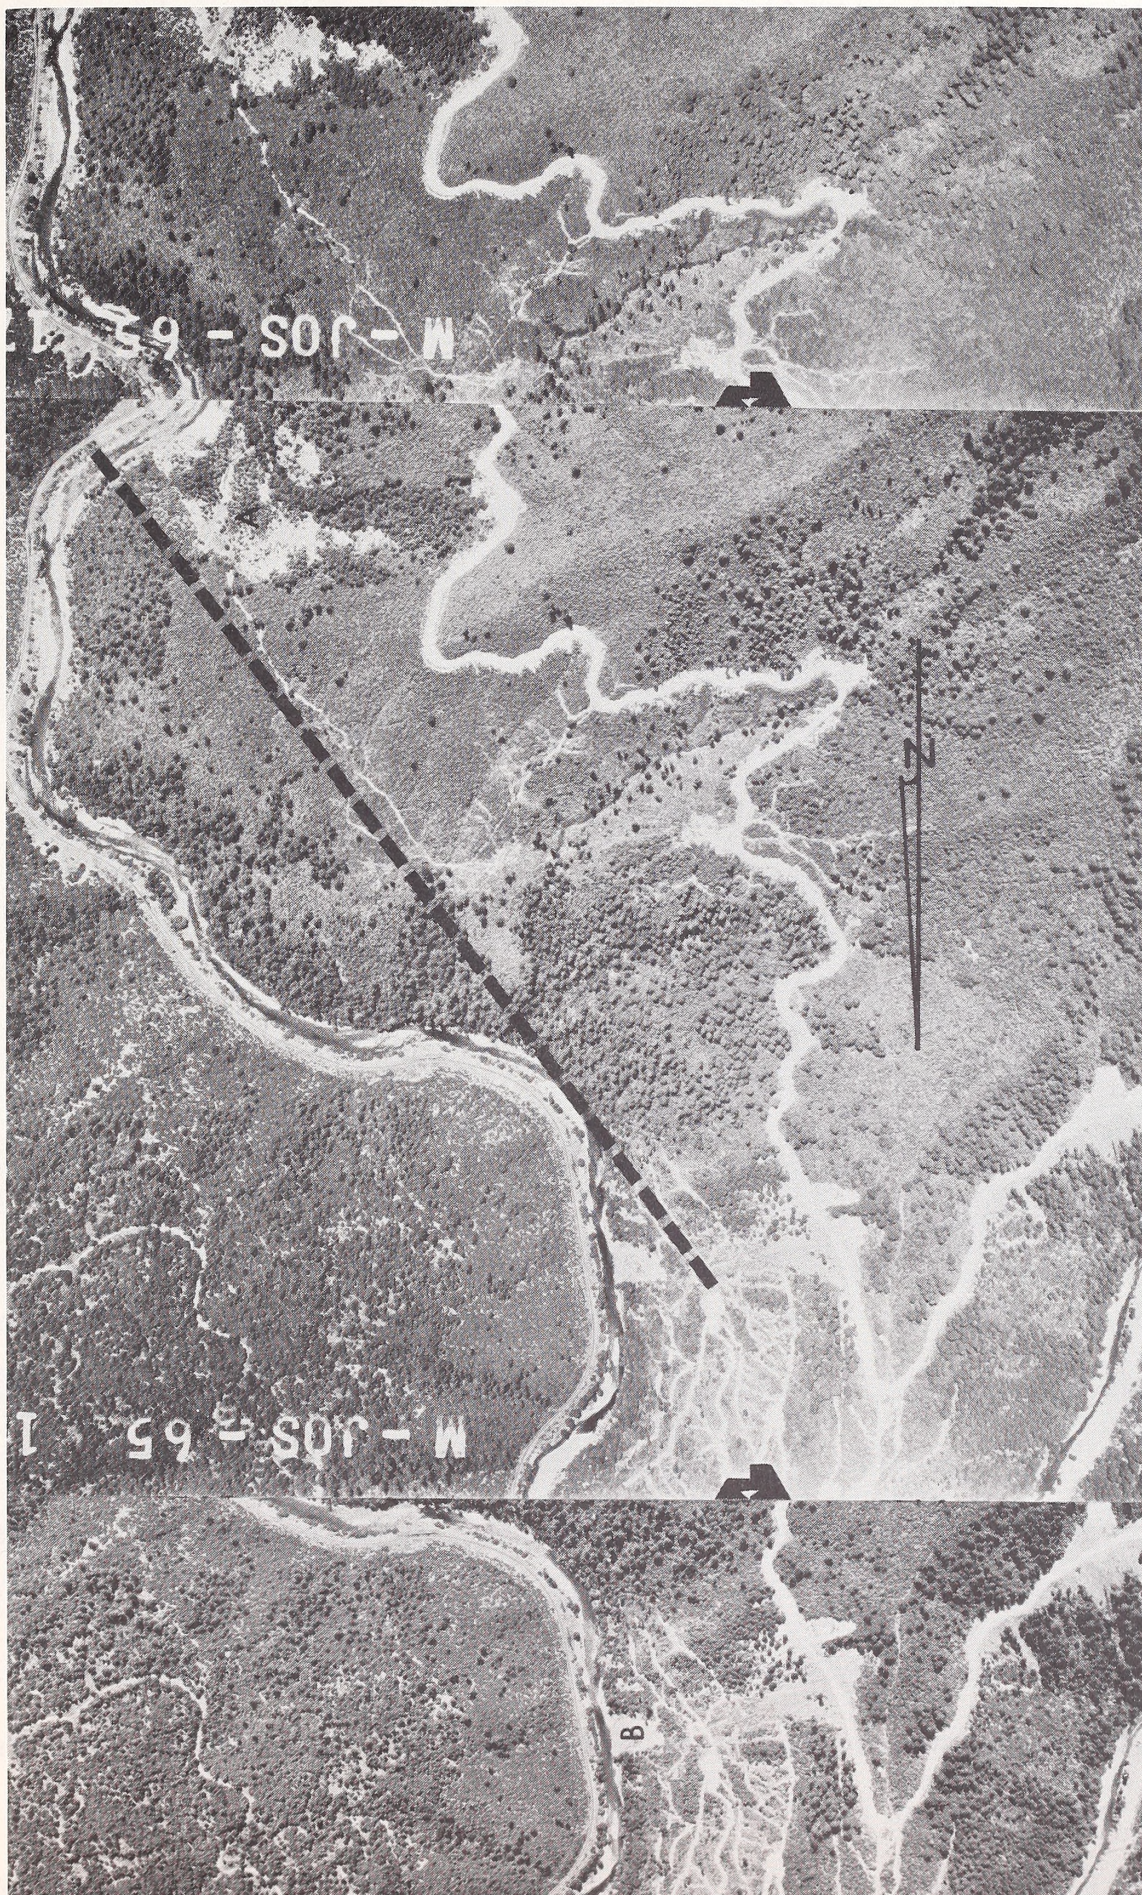
Figure 23. Stereogram of a possible fault zone. The location of the fault is indicated by the dashed line through the low saddle between the large, older slump at A and the newer slope failure at B.

Aerial photographs should be carefully examined for possible fault zones when neither geologic maps nor topographic maps offer any clues. Figure 23 is a stereogram of a portion of Cow Creek, south-southwest of Roseburg, together with a portion of the topographic map of this area. A possible fault zone is indicated

on the stereogram; note that it passes through several saddles and begins and ends in Cow Creek. Also note the large, old slide at A and the newer slide at B. These photographs were taken in 1965; since then a highway has been constructed along Cow Creek on the bank across from the railroad. The slide at B has enlarged, has been actively moving, and has buckled the highway at the base of the slide. Further evidence of a fault zone through this area is shown in the photograph of a rock from the slide at B (Figure 24). The important feature is the slick, shiny surfaces, called "slickensides", that are caused by the intense heat developed by friction on sliding surfaces within a fault zone.

Figure 39. A photo of the rockslide illustrated at point B in Figure 23. Note how the shifting rock is lifting the road and moving it to the right towards Cow Creek

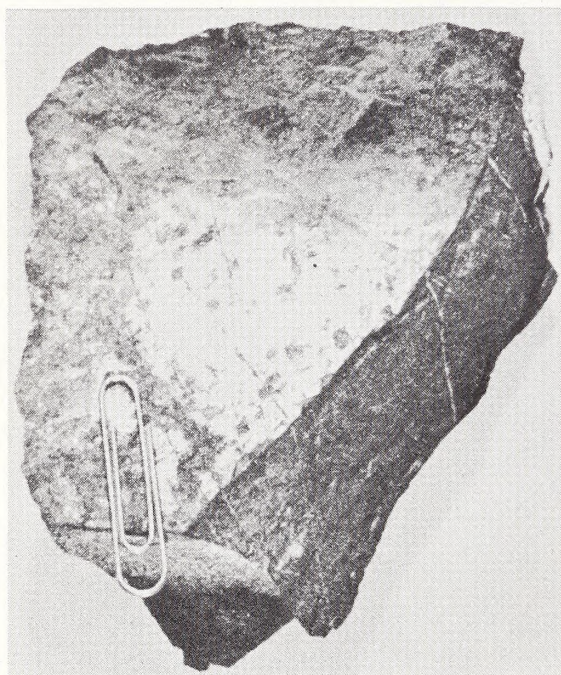
Figure 24. A rock from the rockslide at point A on Figure 3. Note the shiny surface.

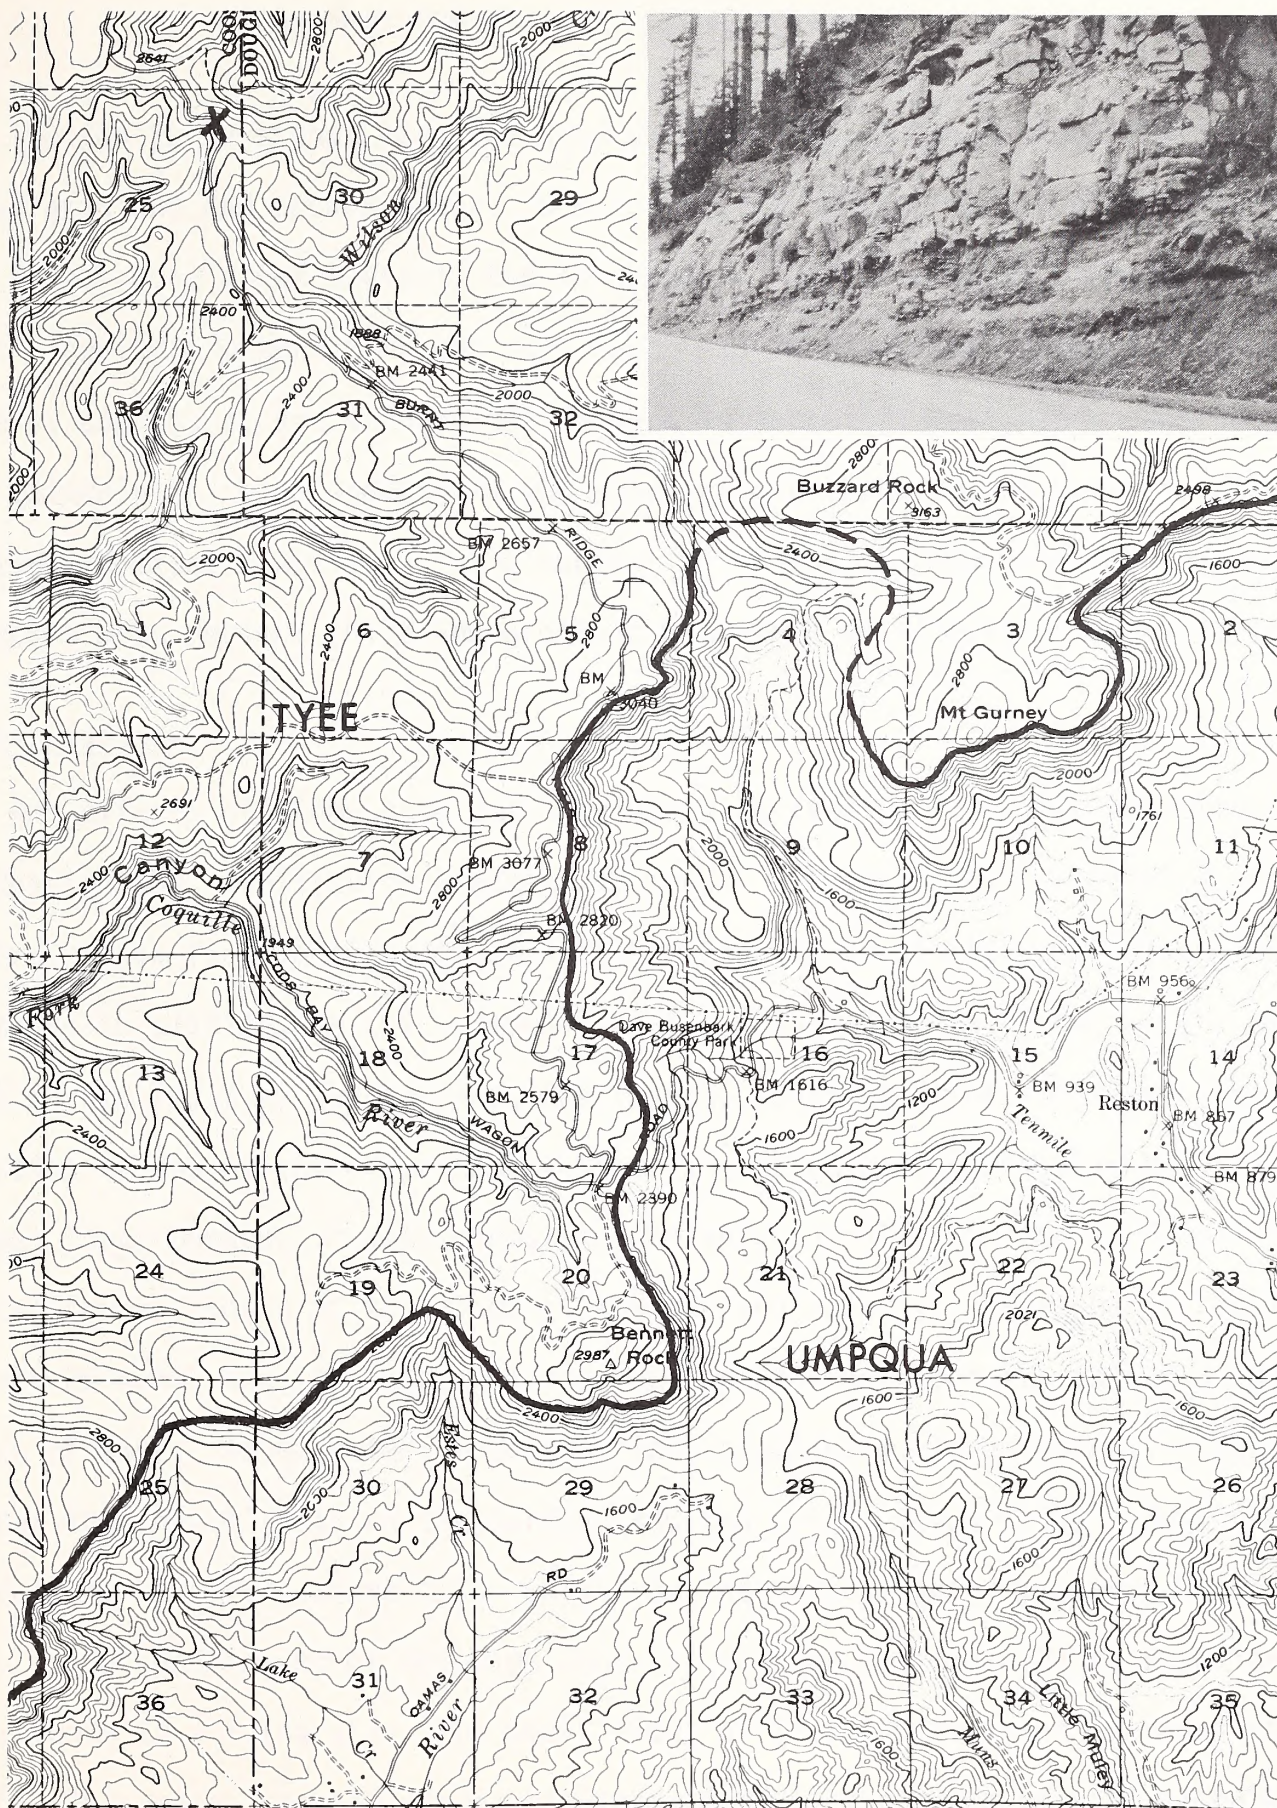
Figure 28. Topographic map of the Camas Valley Quadrangle. The Tyee sandstone is a more competent formation than the Umpqua formation in this area, and forms cliffs at the junction of these two formations. A photo of the contact between these two formations is shown in the upper right. The location of this photo is shown by the X in the upper left.

Geologic maps and topographic maps used together can help locate, relatively accurately, the boundary between geologic materials with different values of competence and resistance to weathering. Figure 28 is a portion of a topographic map of the Camas Valley quadrangle west-southwest of Roseburg. Note the change in slope gradient from the Tyee sandstone to the underlying Umpqua formation. The boundary of these two formations is indicated by the hatched line. The Tyee formation is more competent and has a greater resistance to weathering than does the Umpqua formation. This difference is indicated by the cliff-forming character of the Tyee formation. The Umpqua formation weathers rapidly to moderate slopes because of the high percentage of siltstone in the formation in this area. A picture of the contact between the Tyee and the darker Umpqua formation is inserted in the upper corner of Figure 28. The location of this photo is indicated by the X in the upper left corner of the map.

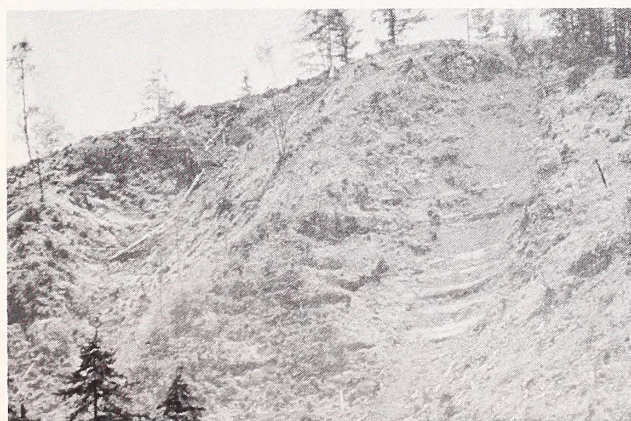
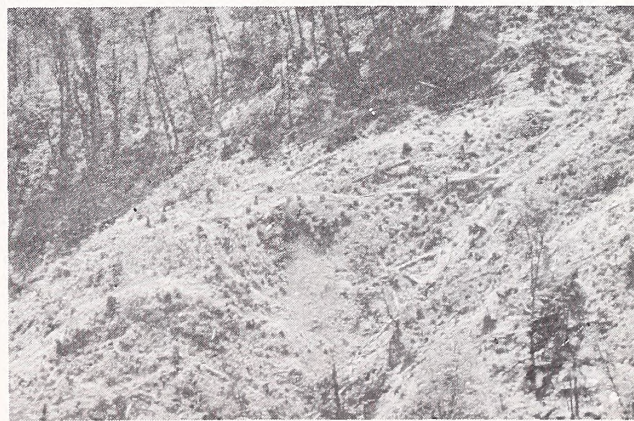
Figures 35 and 36 (below). These photographs show shallow landslides that originate on clearcut areas. They often occur in small drainages where ground water may accumulate.

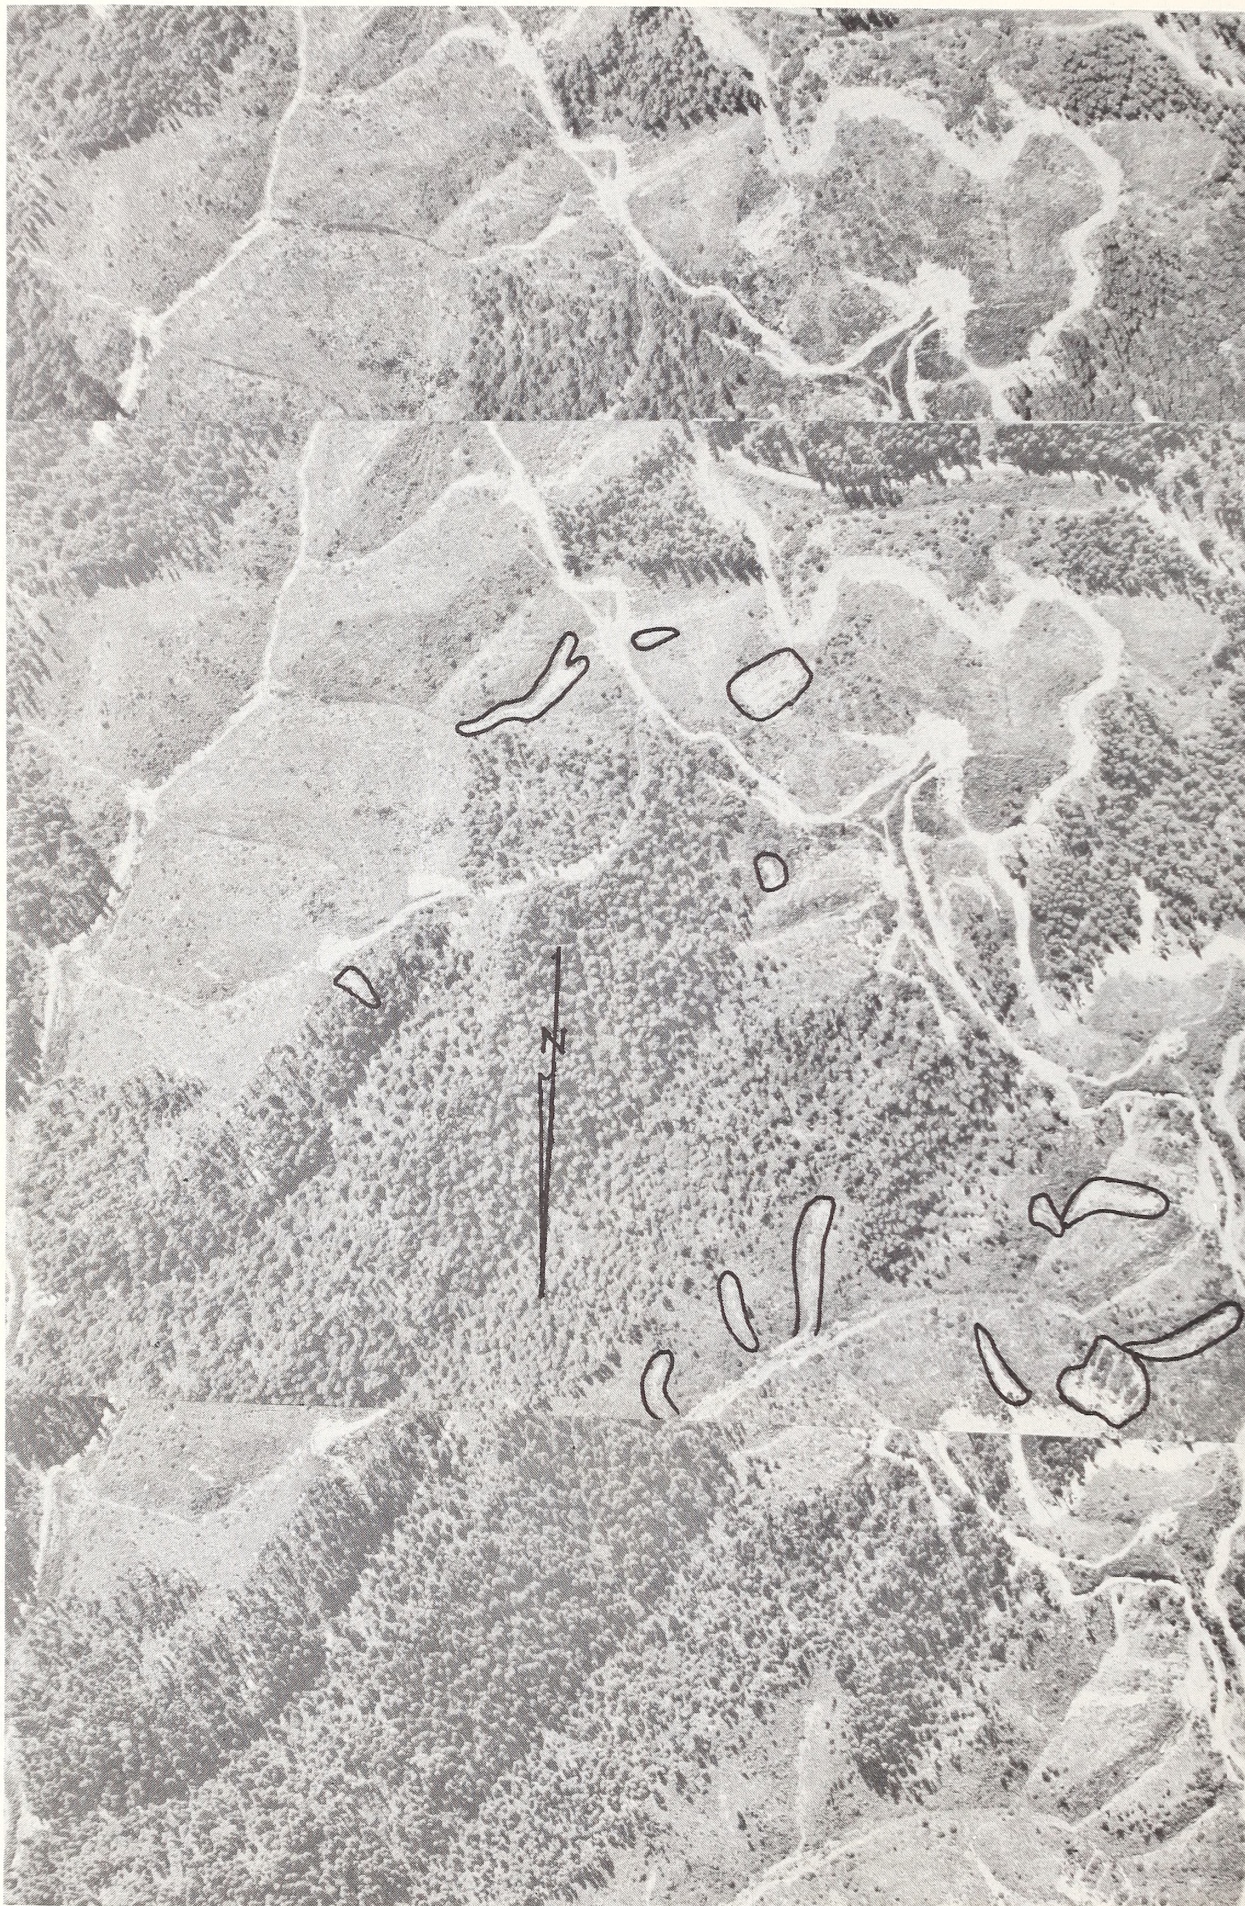
Figure 37. This stereogram shows slope failures that have originated on clearcut areas. The failures outlined in black are not associated with roads.

help maintain slope stability. Reports by the Forest Service from southeast Alaska indicate that the number of landslides from cut-over areas increases within 3 to 5 years after logging. This increase is attributed to a reduction in soil shear strength caused by the decay of tree roots following logging. The presence of living tree roots to anchor shallow soils to the underlying subsoil (Figure 34) appears to be particularly important in small drainages where winter storms can cause the ground water level to rise sharply (Swanston, 1970). Similar correlations between the number of landslides following timber cutting and steep slopes with heavy winter rainfall have been noted in other parts of the United States and other countries (Gray). Figures 35 and 36 show typical slope failures that frequently originate within clearcut areas in shallow depressions on steep side slopes. Figure 37 is a stereogram that shows a number of failures on clearcut slopes that have not been roaded.

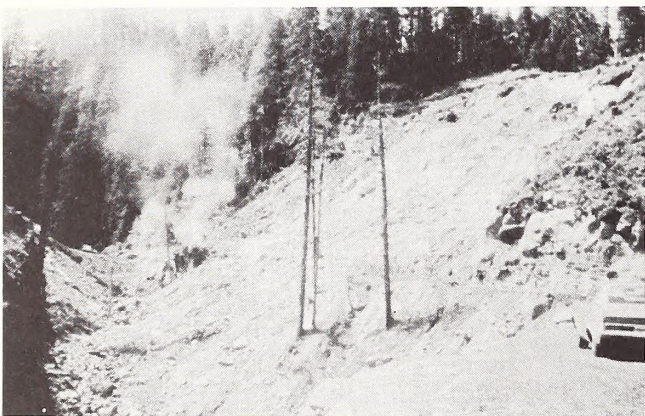
Figure 38. A rockslide in bedded sedimentary material

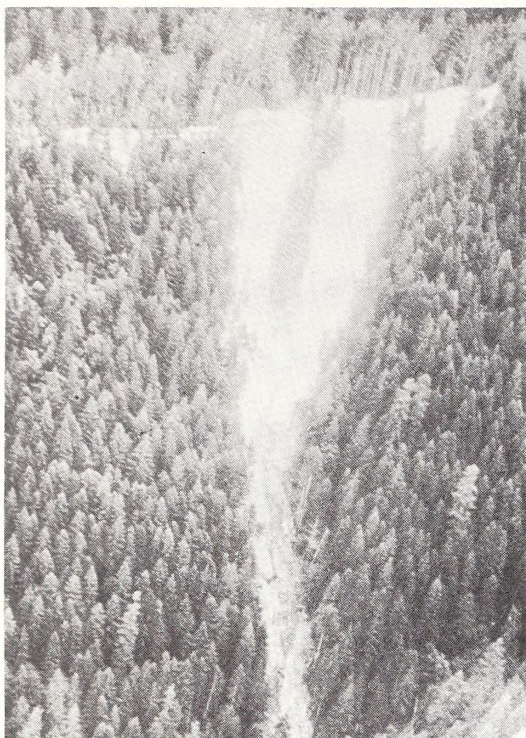
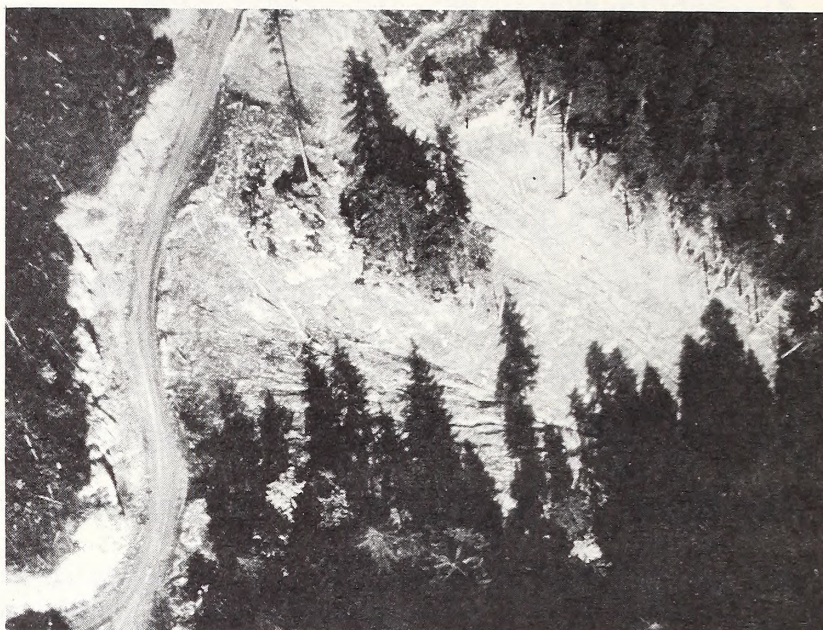
Figure 40 (left) and Figure 41 (above). These are two examples of debris avalanches in shallow soils on steep slopes.

These two closely related types of slope failures usually originate on shallow soils relatively low in clay content on steep (>65%) slopes (Figures 40 and 41). In southeast Alaska, the Forest Service has found that debris avalanches develop on slopes greater than 65 percent on shallow, gravelly soils and that this type of slope failure is especially frequent on slopes over 75 percent (Swanston, 1969 and 1970). An excellent description of debris avalanches and flows is given in Bailey, parts of which are quoted below:

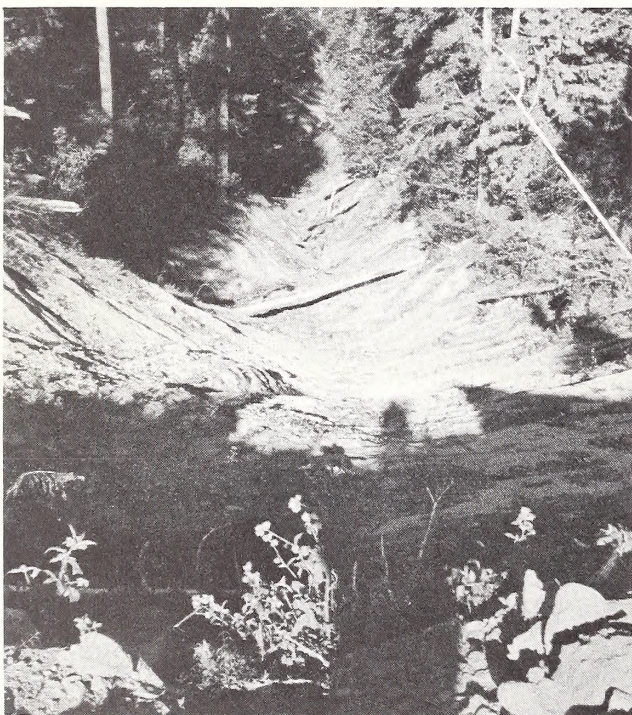
Figure 42 (left). Frequent debris avalanches may create round-bottomed chutes.

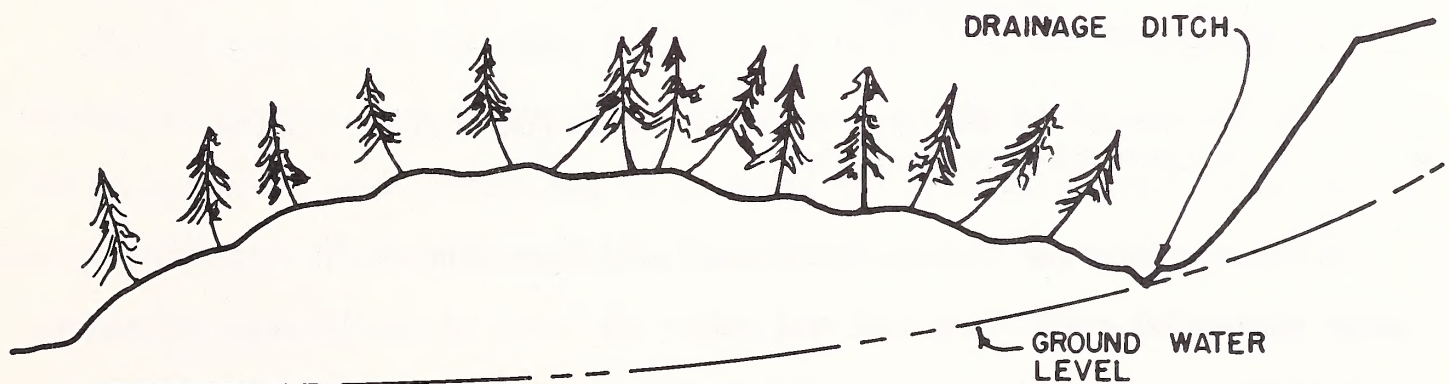
HOW DRAINAGE OF SURFACE WATER CAN INCREASE SLOPE STABILITY

SAG PONDS ADD WATER TO THE GROUND WATER RESERVOIR AND INCREASE THE POTENTIAL FOR FURTHER SLUMPING.

DITCHES CAN DRAIN SAG PONDS, LOWER THE GROUND WATER LEVEL, AND INCREASE SLOPE STABILITY.

Figure 49. Drainage of surface water can increase slope stability by lowering the ground water level

Assuming that it is absolutely necessary to locate a road through terrain with a potential for slumping, there are several techniques that may be considered to prevent slumps and earthflows. Improved surface drainage is one of the cheapest and most effective techniques and one that is often overlooked. Sag ponds and depressions can be connected to the nearest stream channel with ditches excavated by bulldozer or ditching powder. Figure 49 shows the theoretical effect on the ground water reservoir of a surface drainage project. Improved surface drainage removes water quickly, lowers the ground water level, and helps stabilize the slump.

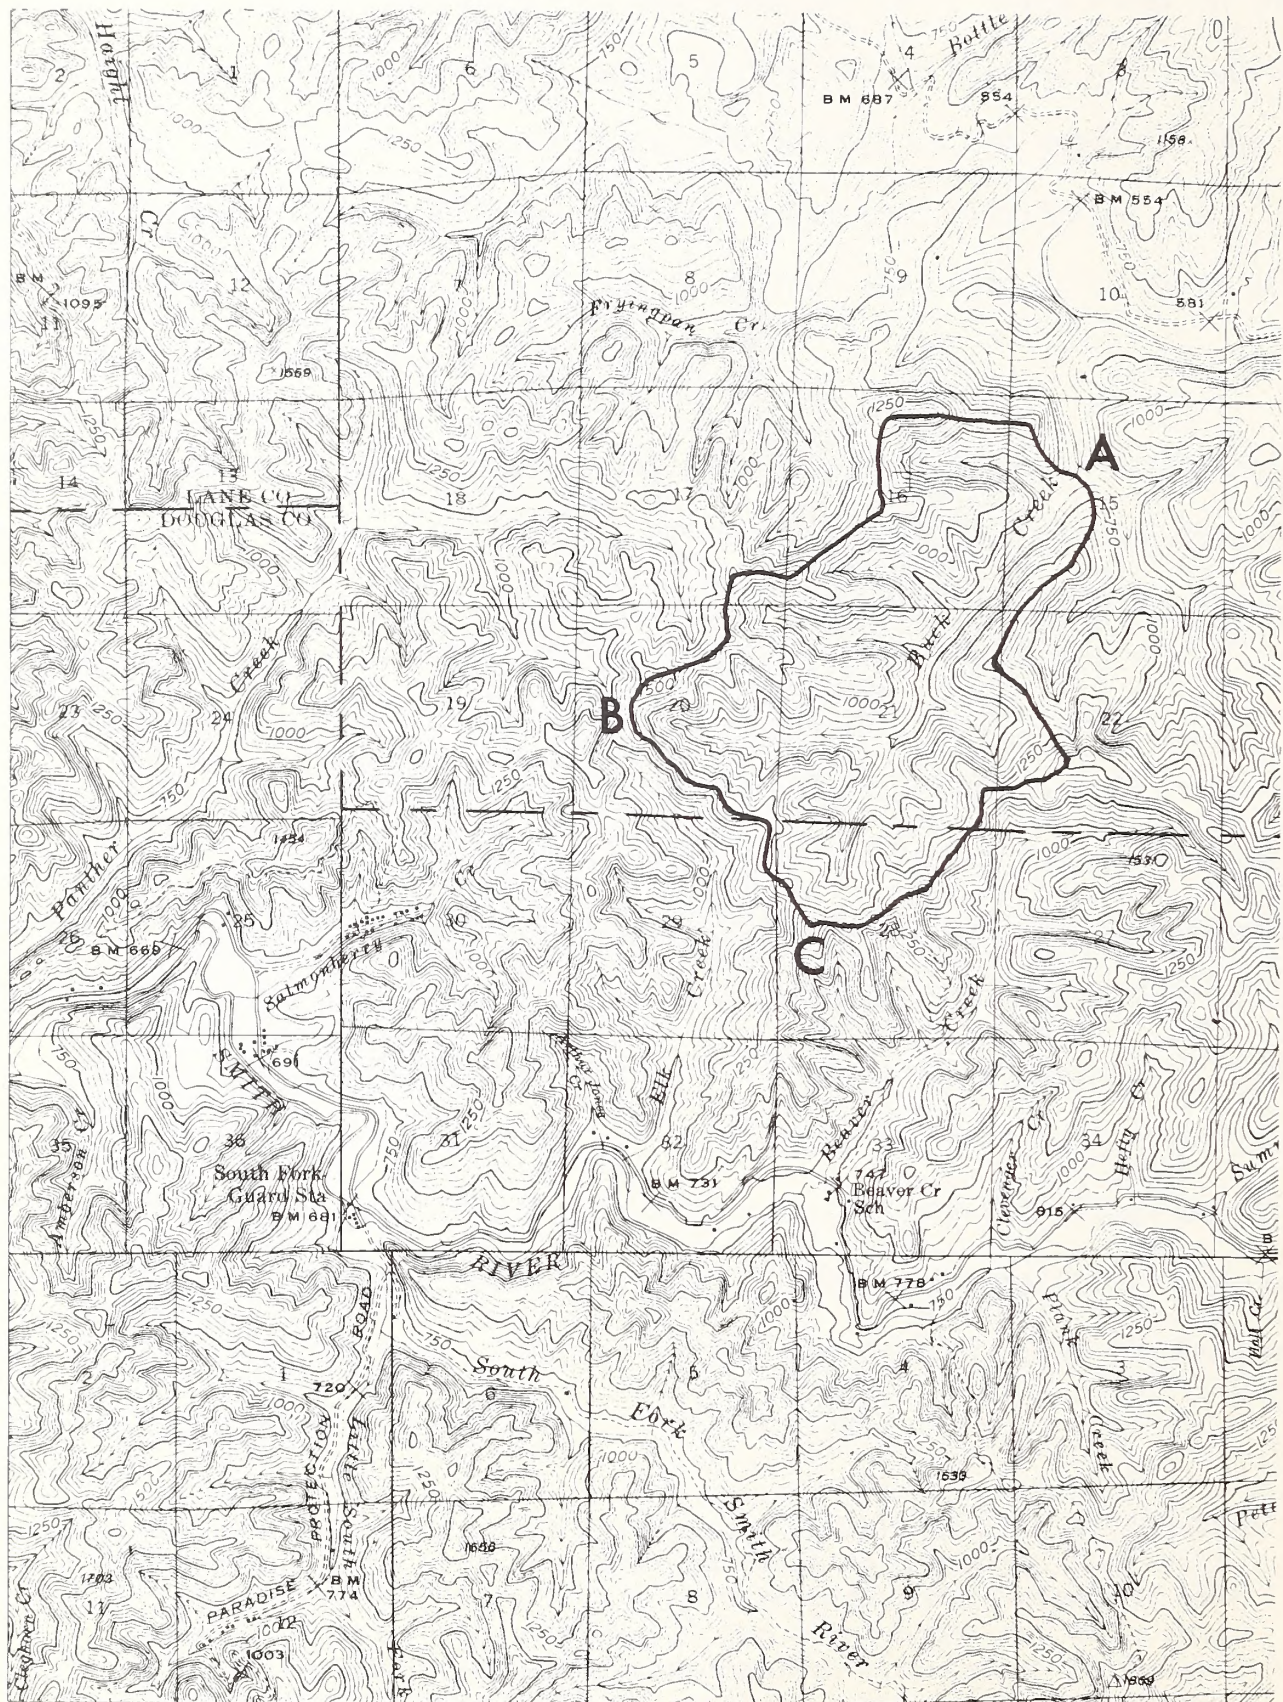
Figure 53. A topographic map of the steep terrain with sandstone bedrock where debris avalanches are the most common type of slope failure. The basin outlined in black is shown in the block diagram in Figure 52. Points A, B, and C may be used for orientation. Note the characteristic drainage pattern. Compare with Figure 66.

Figure 53 shows the steep, highly dissected terrain that is distinctive of Type I sites in western Oregon. Small scale topographic maps (such as the Western United States, 1:250,000 scale) may be used with Figure 2 to outline areas within the bedded sediments that are likely to have Type I slope stability problems. Some of these areas are: tributaries on the north side of the Alsea

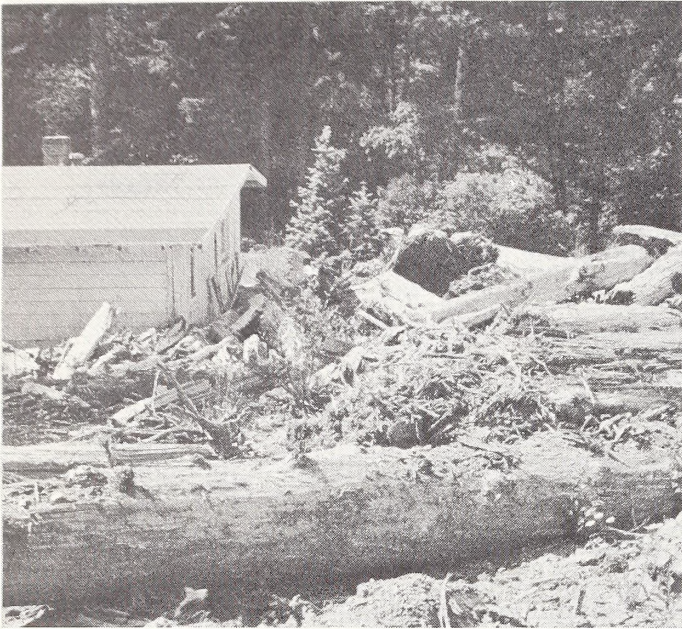
Figure 56. The result of a debris avalanche from a road fill in a headwall in sandstone material

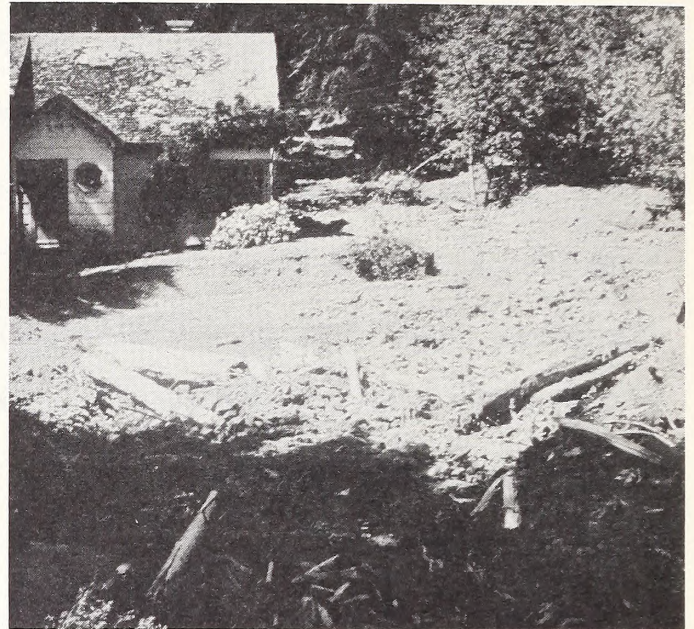
Figure 57. A debris flow came down the stream channel just to the right of the house
